TEKSI / TEKSI EKSEKUTIF / TEKS1M INSPECTION GUIDELINES

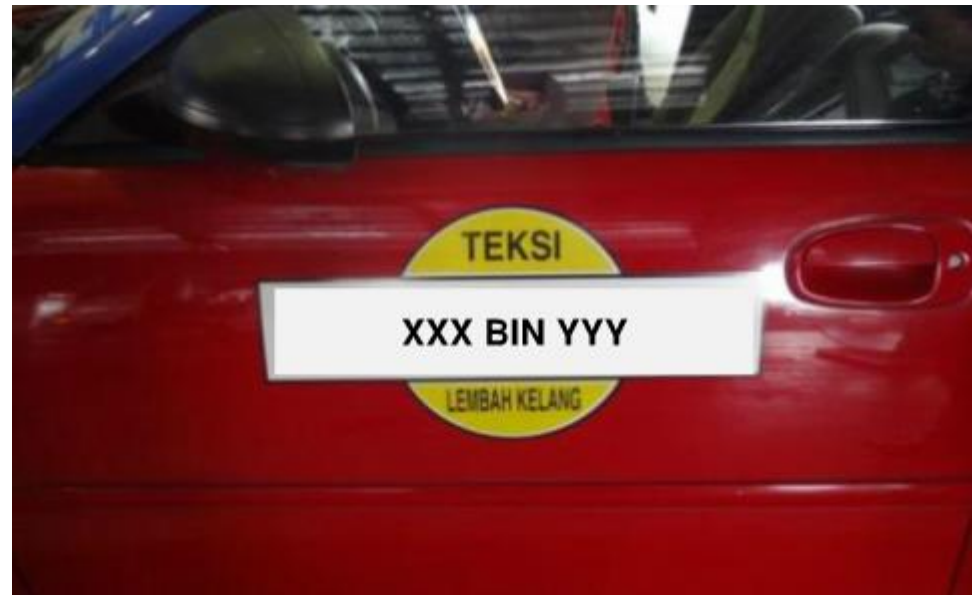
- Body lettering
 - i. Teksi : The name of the licensee to be displayed at left and right of front door with yellow circle and white rectangle box, refer Figure 1
 - ii. Teksi Eksekutif : The name of the licensee to be displayed at left and right of front door with white circle and rectangle box, refer Figure 2
 - iii. TEKS1M : "TEKS1M" and the name of the licensee to be displayed at left and right of rear panel, refer Figure 3
: "TEKS1M" at front of vehicle hood, refer Figure 4

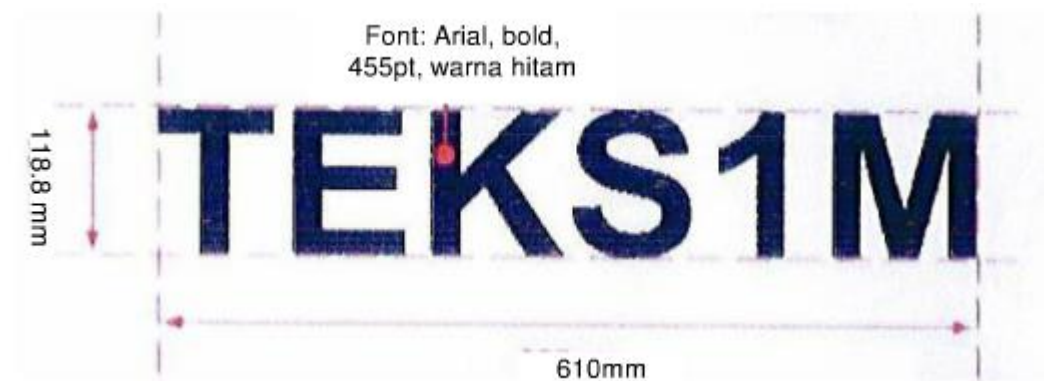
Figure 7

- Body lettering measurement
 - i. Teksi, refer Figure 5
 - ii. Teksi Eksekutif, refer Figure 6
 - iii. TEKS1M, refer Figure 7, Figure 7a and Figure 7b

Body lettering measurement at front of vehicle hood

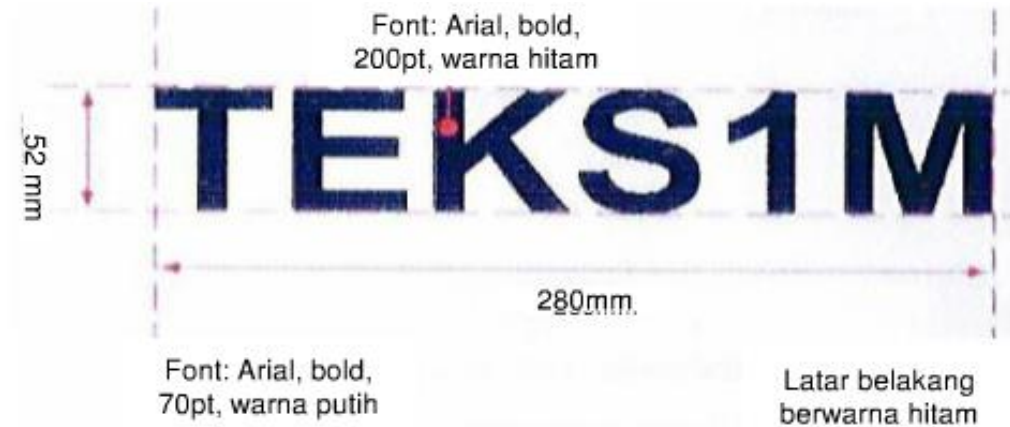
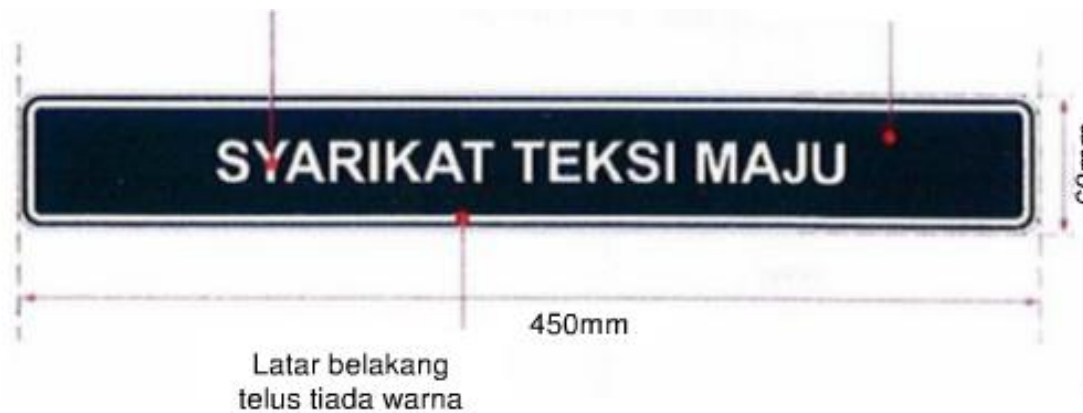
Figure 7b

Body lettering measurement at rear side of vehicle

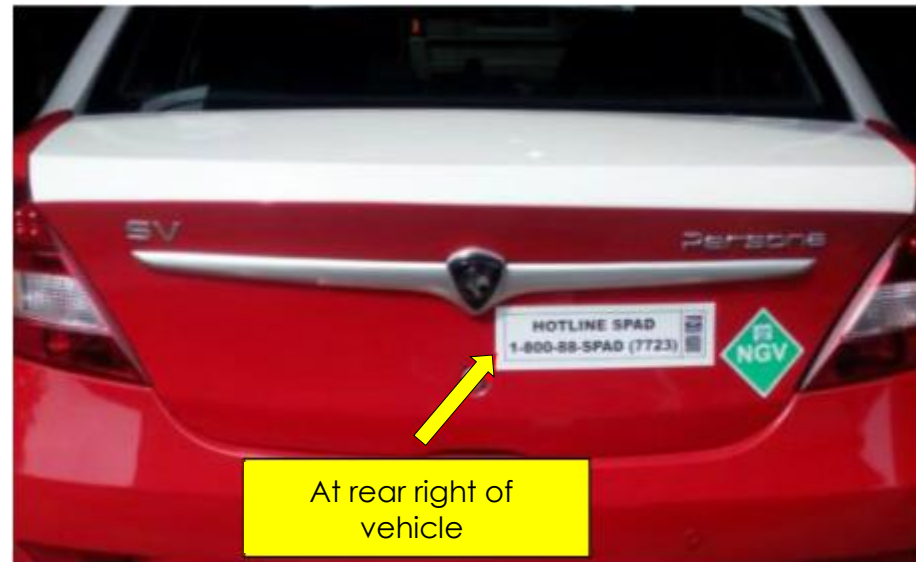
- To display Hotline SPAD sticker (Peninsular Malaysia) at rear right of vehicle, refer Figure 8

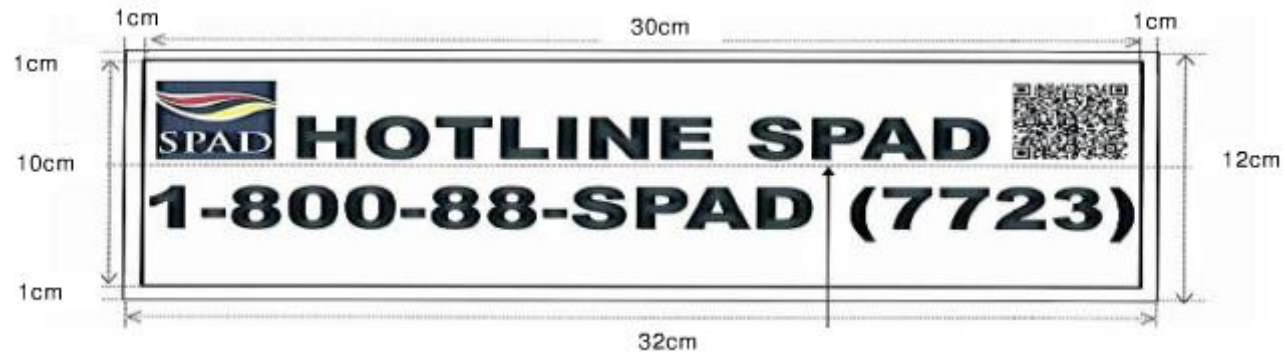
- Hotline SPAD sizes (Outer), refer Figure 9
 - i. Type of font : Arial Black
 - ii. Font size : 72
 - iii. Background color : White (Reflector)
 - iv. Font color : Black
 - v. SPAD logo size : 3.5cm x 3.5cm
 - vi. QR code size : 3.5cm x 3.5cm

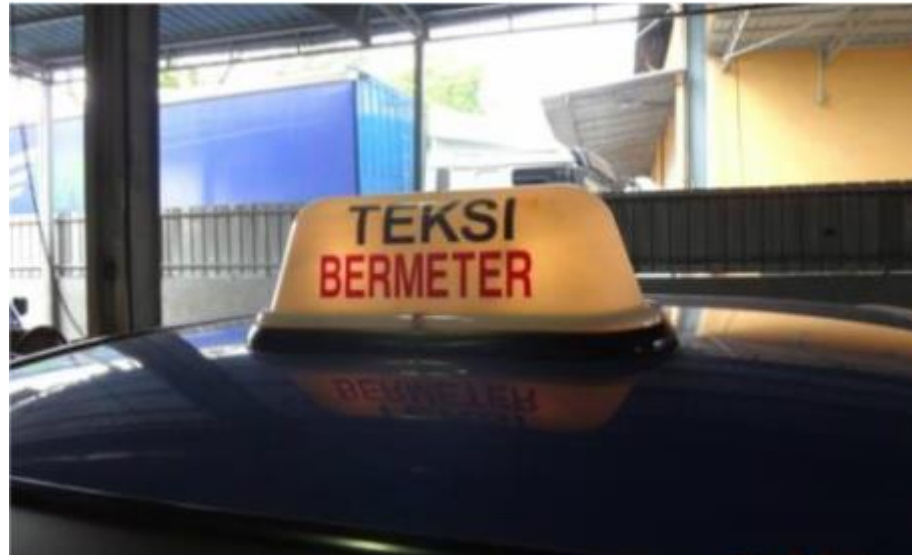
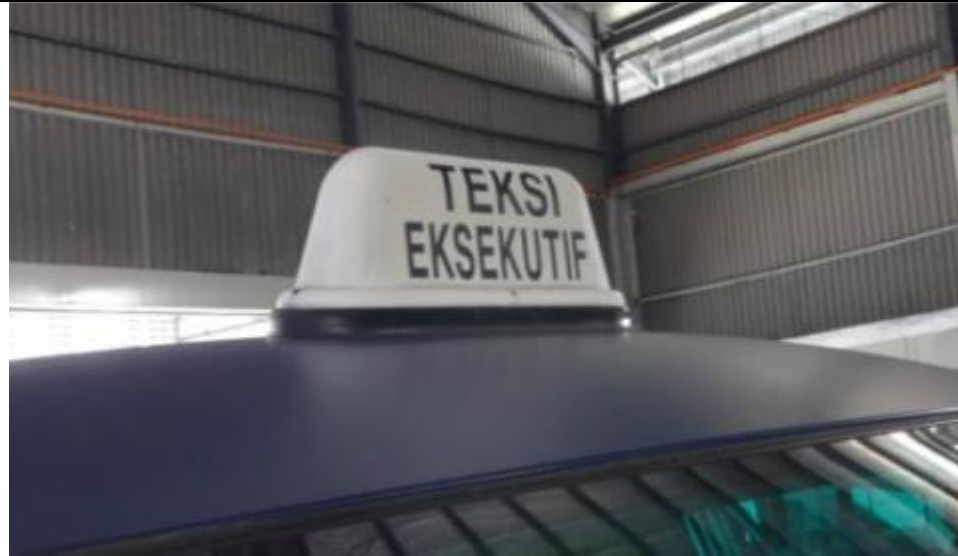
- Roof Top Sign for Teksi and Teksi Eksekutif to show occupancy of taxi, refer Figure 10 and Figure 10a

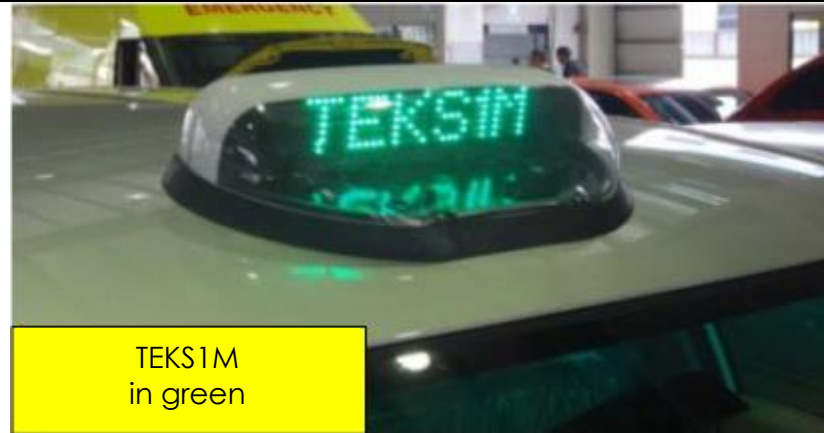
- Roof Top Sign for “TEKS1M”
 - i. Equipped with Light Emitting Diode (LED) light
 - ii. “TEKS1M” in green to show taxi ready for hire, refer Figure 11
 - iii. “HIRED” in red to show taxi in hire, refer Figure 12

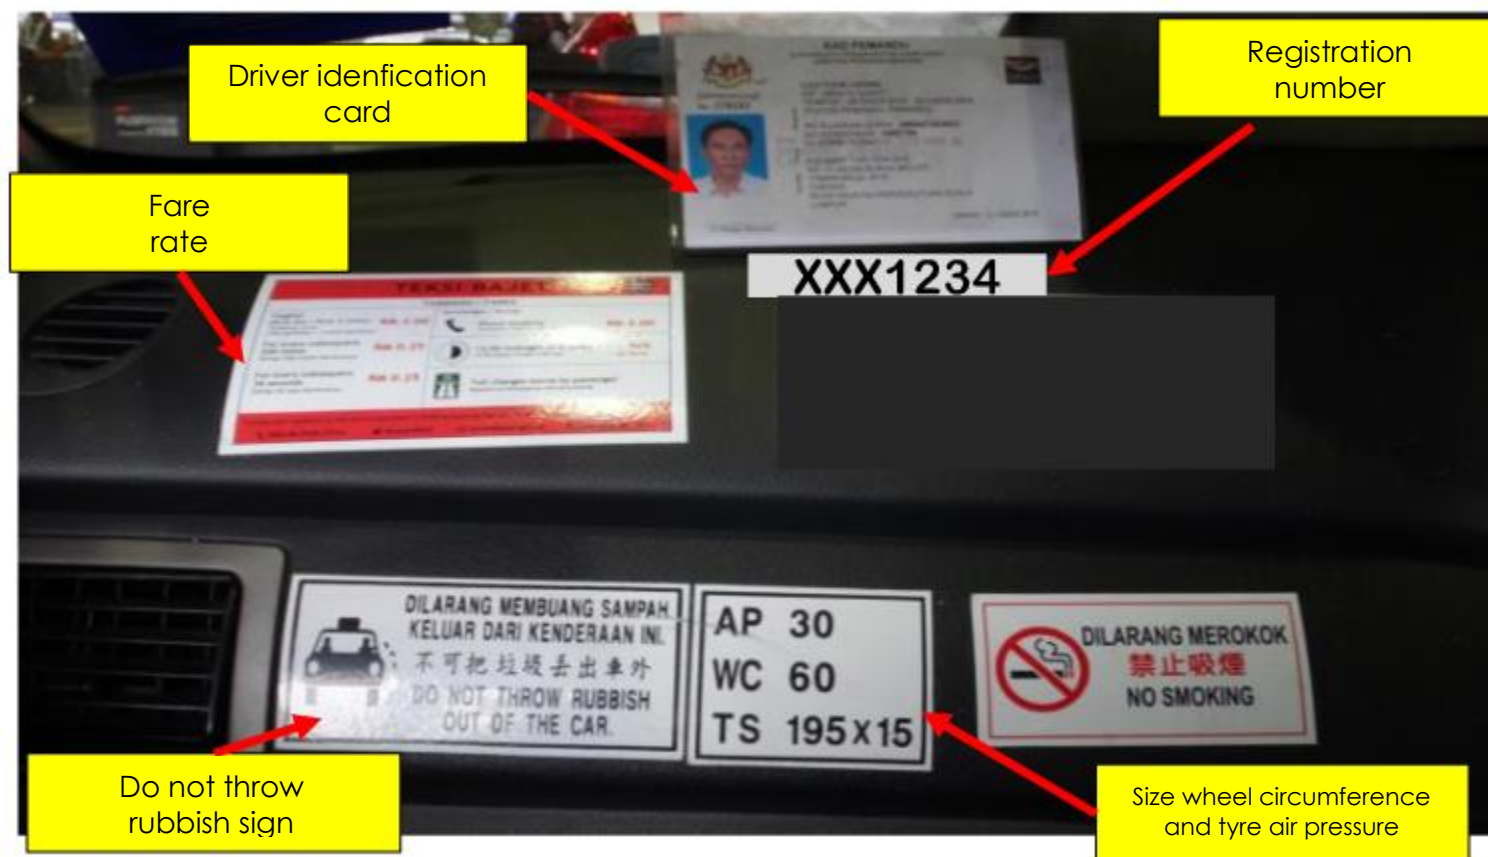
- Displayed at dashboard, refer Figure 13
 - i. Driver identification card
 - ii. Registration number
 - iii. Fare rate
 - iv. Size wheel circumference and tyre air pressure
 - v. "DILARANG MEMBUANG SAMPAH KELUAR DARI KENDERAAN INI" sign

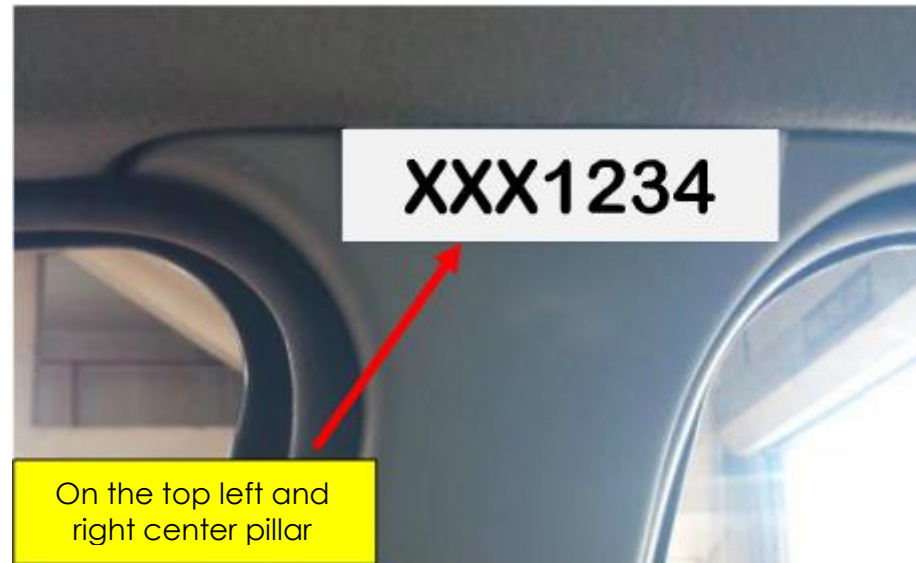
- To display vehicle registration number on top left and right center pillar, refer Figure 14

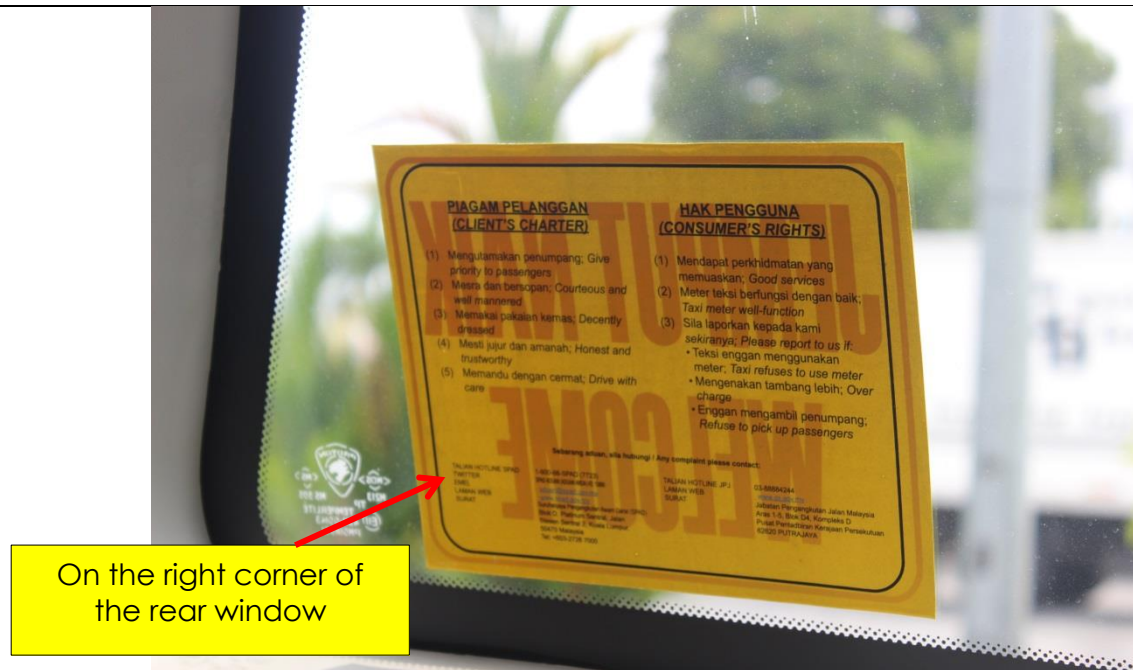
- To display customer charter in the interior of vehicle:
 - i. Teksi and Teksi Eksekutif : On the right corner of the rear window, refer Figure 15 and Figure 16
 - ii. TEKS1M : A4 size with landscape orientation at behind driver's seat, refer Figure 17

On the right corner of
the rear window

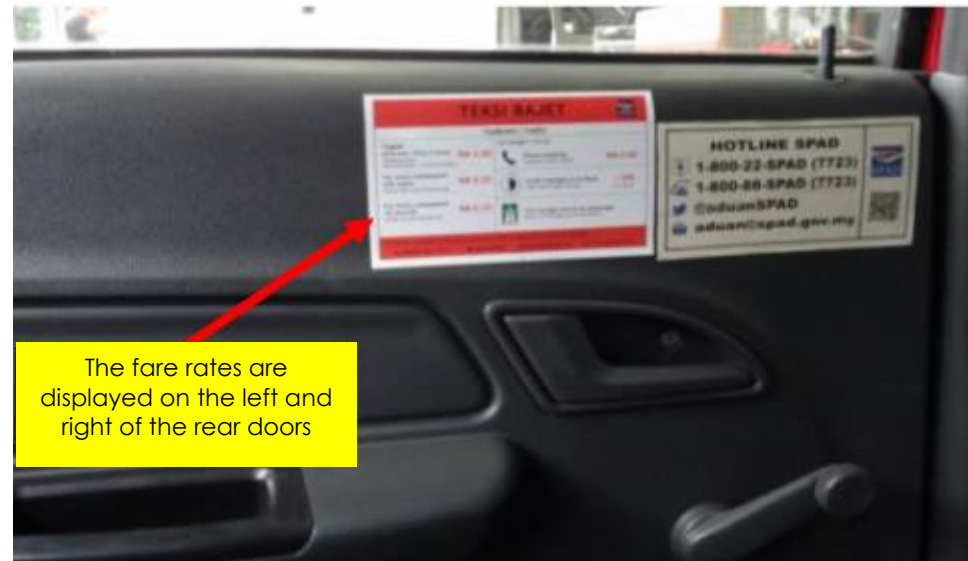
- Displayed fare rate:
 - i. Teksi and TEKS1M : On the left and right of the rear doors, refer Figure 18 and Figure 20
 - ii. Teksi Eksekutif : On the left of the rear door, refer Figure 19

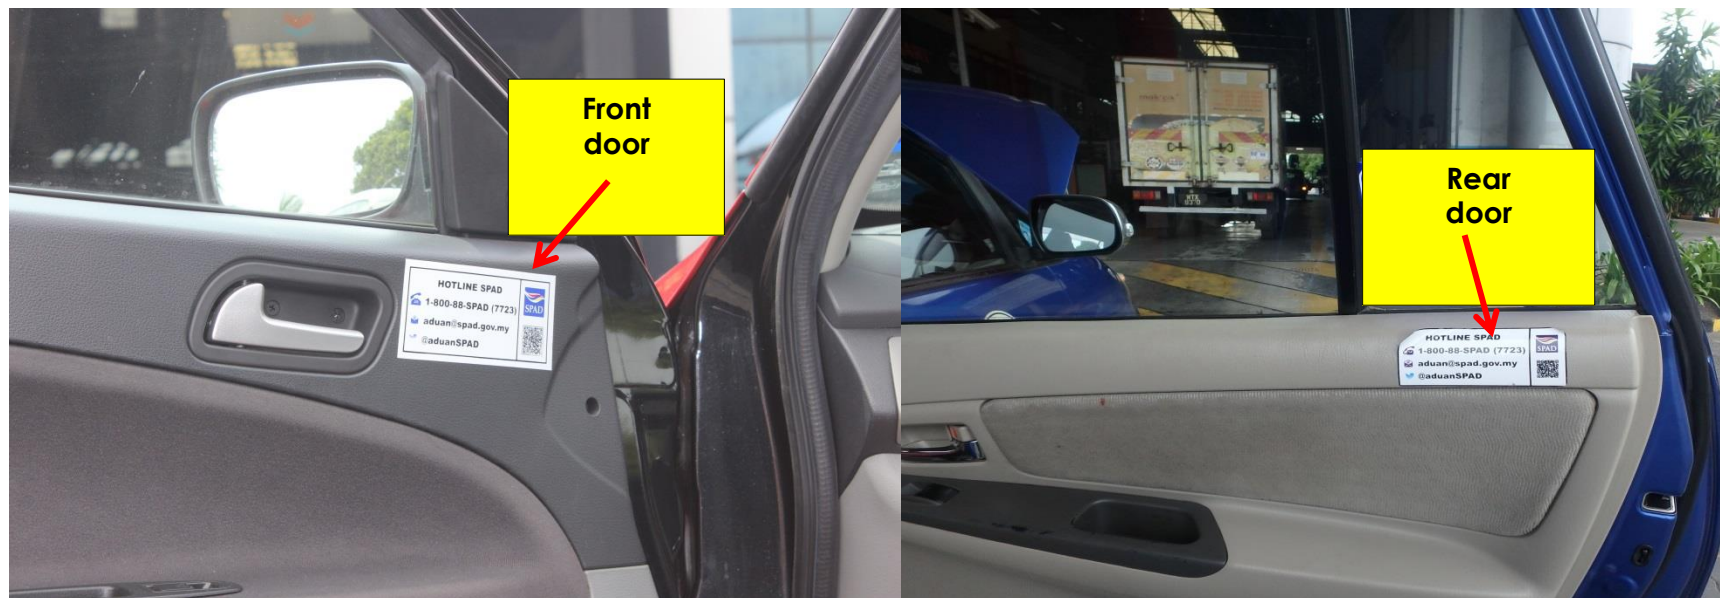
- To display Hotline SPAD stickers (Peninsular Malaysia) at all doors except driver side, refer Figure 21

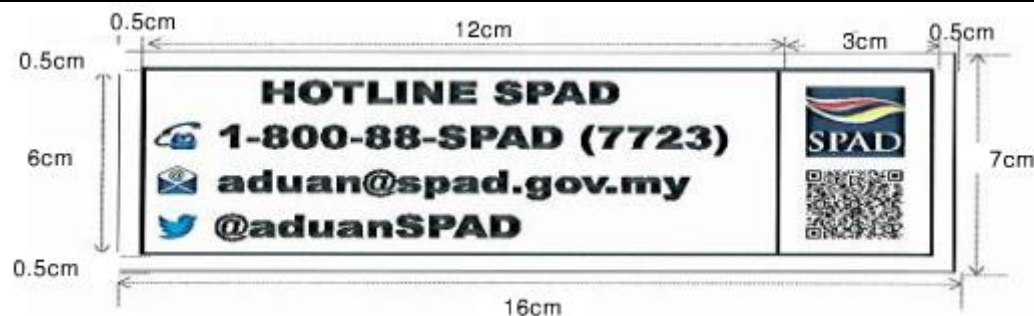
- Hotline SPAD measurement (Inner), refer Figure 22
 - i. Type of font : Arial Black
 - ii. Font size : 20
 - iii. Background color : White
 - iv. Font color : Black
 - v. SPAD logo size : 2cm x 2cm
 - vi. QR code size : 2cm x 2cm

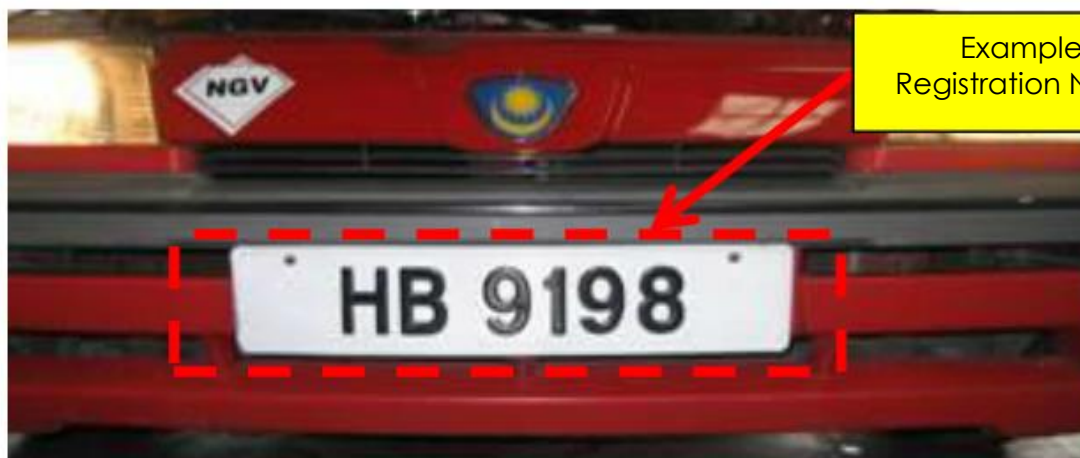
Registration Number	<ul style="list-style-type: none"> • The letters and figures are black, background in white, refer Figure 23 • Letter and figure sizes, refer Figure 24 <ul style="list-style-type: none"> i. Height : 70mm ii. Width : 40mm iii. Thickness : 10mm iv. Space between letter and figure : 30mm v. Space between letters / figures : 10mm • Displayed clearly, neatly, not broken and not blocked
---------------------	--

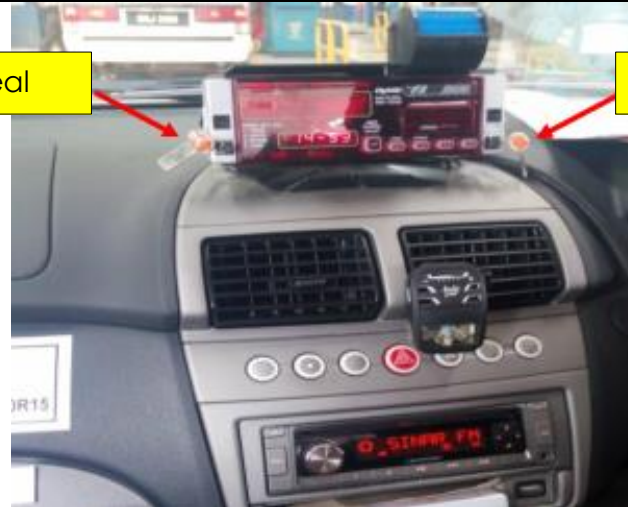
- Well function
- Position on the middle top of dashboard, refer Figure 25 and Figure 25a
- Fitted neatly, meter seal not broken and not blocked, refer Figure 25 and Figure 25a
- Information must displayed in clear and easy to understand
- Able to print receipt (content of receipt subject to SPAD directives)

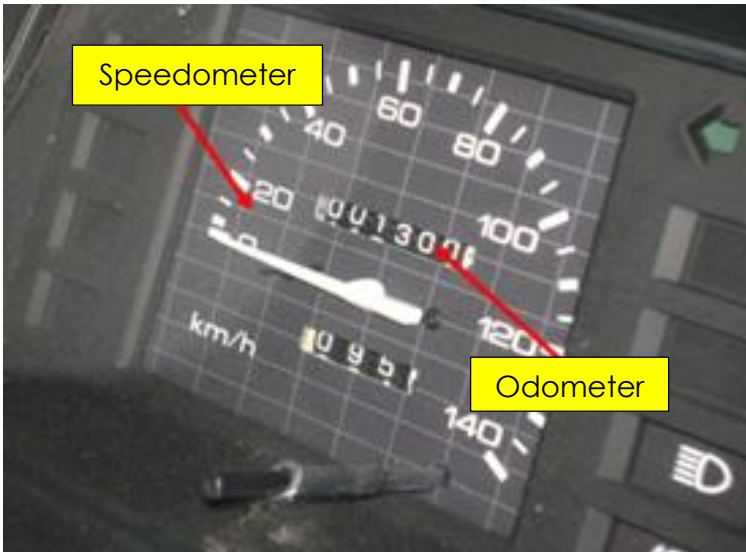
Speedometer / Odometer	<ul style="list-style-type: none"> • Neat, clean, speed limit is clear and functional, refer Figure 27
